Appendix C Nozzle PFORs

Final Postflight Hardware Evaluation Report RSRM-29 (STS-54)

September 1993

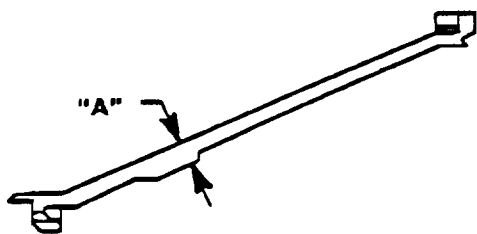
Record the Flexible Bearing Protector Gas Impingement Area Thickness Measurements (see figure) Below:

* "A" is the minimum thickness of the bearing protector in-line with the cowl vent holes. It corresponds to the deepest gas impingement location.

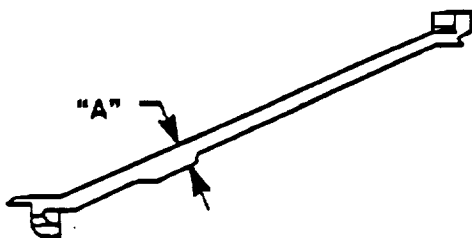
* "A" is the minimum thickness of the bearing protector in-line with the cowl vent holes. It corresponds to the deepest gas impingement location.
